5 WTC 7

5.1 Introduction

WTC 7 collapsed on September 11, 2001, at 5:20 p.m. There were no known casualties due to this collapse. The performance of WTC 7 is of significant interest because it appears the collapse was due primarily to fire, rather than any impact damage from the collapsing towers. Prior to September 11, 2001, there was little, if any, record of fire-induced collapse of large fire-protected steel buildings.

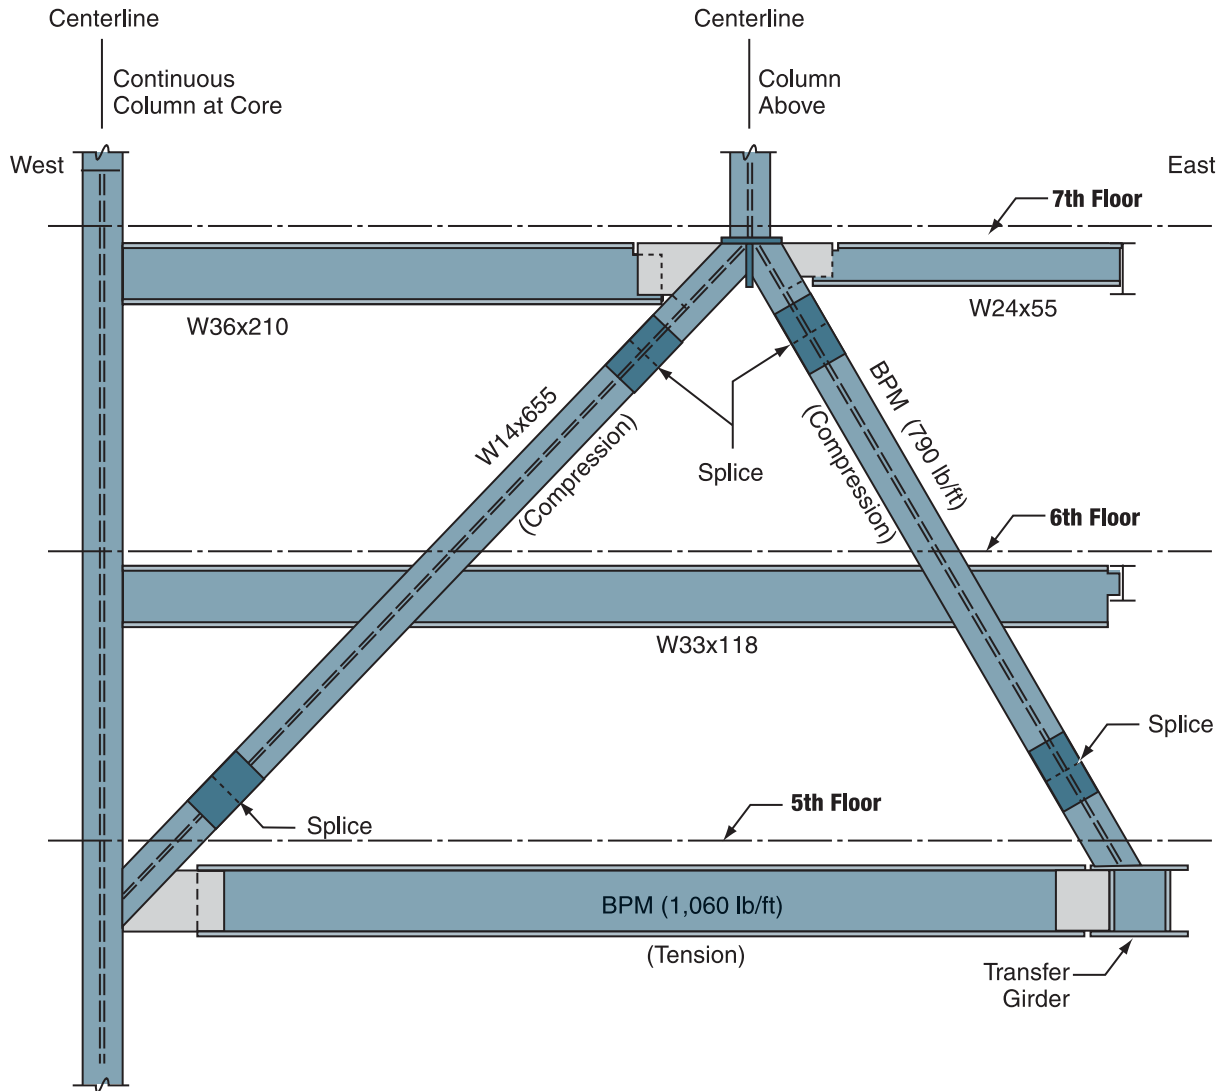
Figure 5-7 Truss 1 detail. (BPM = built-up plate member.)

Truss 1 was situated in the northeast sector of the core, and spanned in the east-west direction. As shown in Figure 5-7, this truss was a two-story double transfer structure that provided load transfers between nonconcentric columns above the 7th floor to an existing column and girder at the 5th floor. The girder then provided a second load transfer to an additional two columns. The 7th floor column supported 41 floors and part of the east mechanical penthouse. Its load was transferred through the triangular truss into a column

located above an existing substation column and girder at the 5th floor. The 36.5-ton built-up double web girder spanned in the north-south direction between two new columns that started at the foundation and terminated at the 7th floor. The truss diagonals were W14 shapes and the horizontal tie was a 22-ton, built-up shape.

- Truss (Figures 5-7 Through 5-9)
- Eight Cantilever Transfer Girders (Figure 5-10)
- Four Transverse Core Elevations (Figure 5-3)
- Elevators

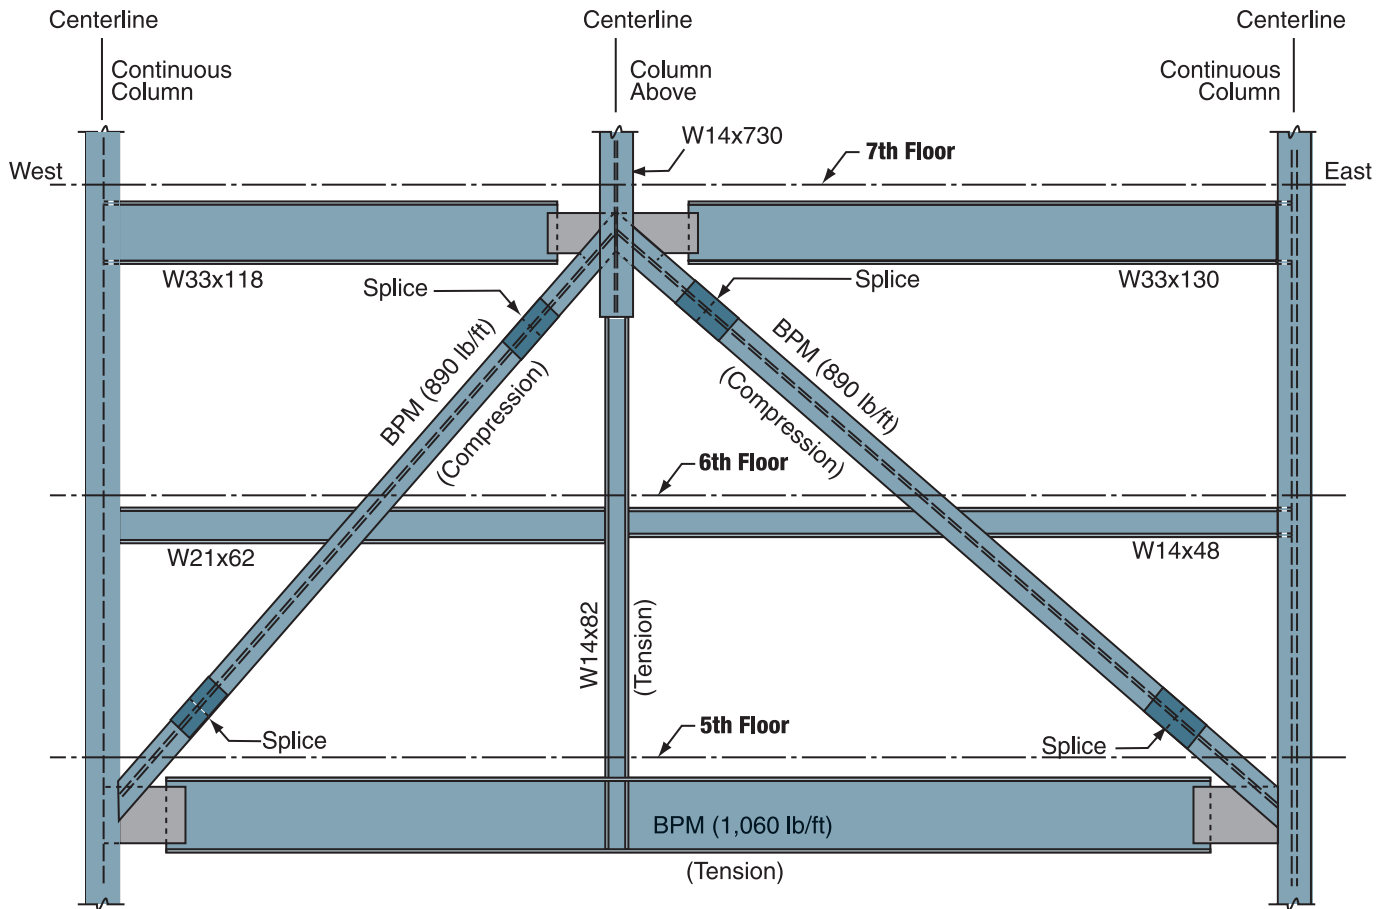
Figure 5-8 Truss 2 detail. (BPM = built-up plate member.)

Truss 2 was a single transfer located south of Truss 1. As shown in Figure 5-8, Truss 2 transferred the column load from the 7th floor through a triangular truss into two existing columns at the 5th floor. Large gusset plates were provided at the connection between the diagonals, the columns, and the horizontal tie. The diagonals and the built-up horizontal tie were field-welded.

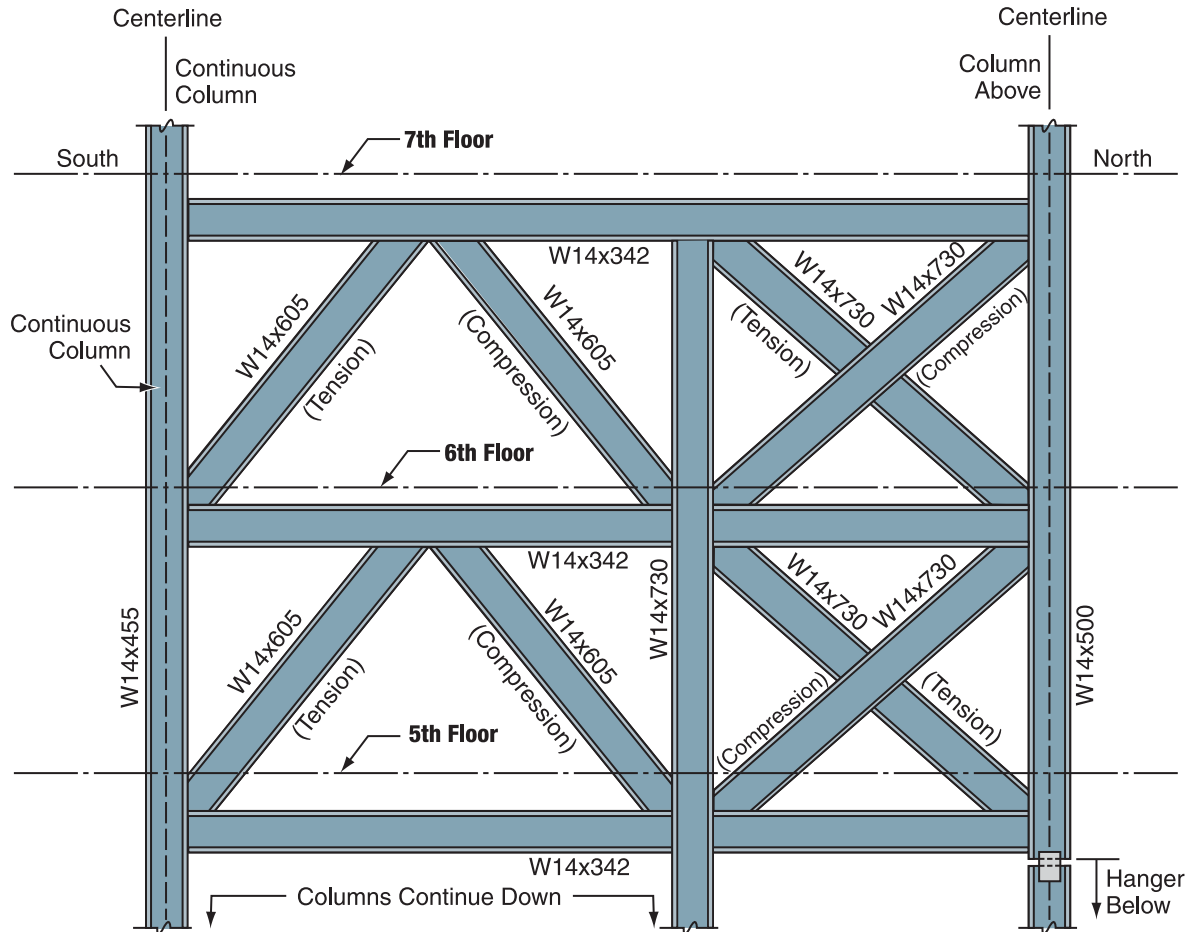
Figure 5-9 Truss 3 detail.

Truss 3 was a cantilevered two-story transfer structure in the north-south direction between the 5th and 7th floors at the western end of the core area. As shown in Figure 5-9, Truss 3 transferred the loads between columns. The upper columns carried 41 floors of load and were cantilevered to the north of the column that went from the foundation to the 7th floor.

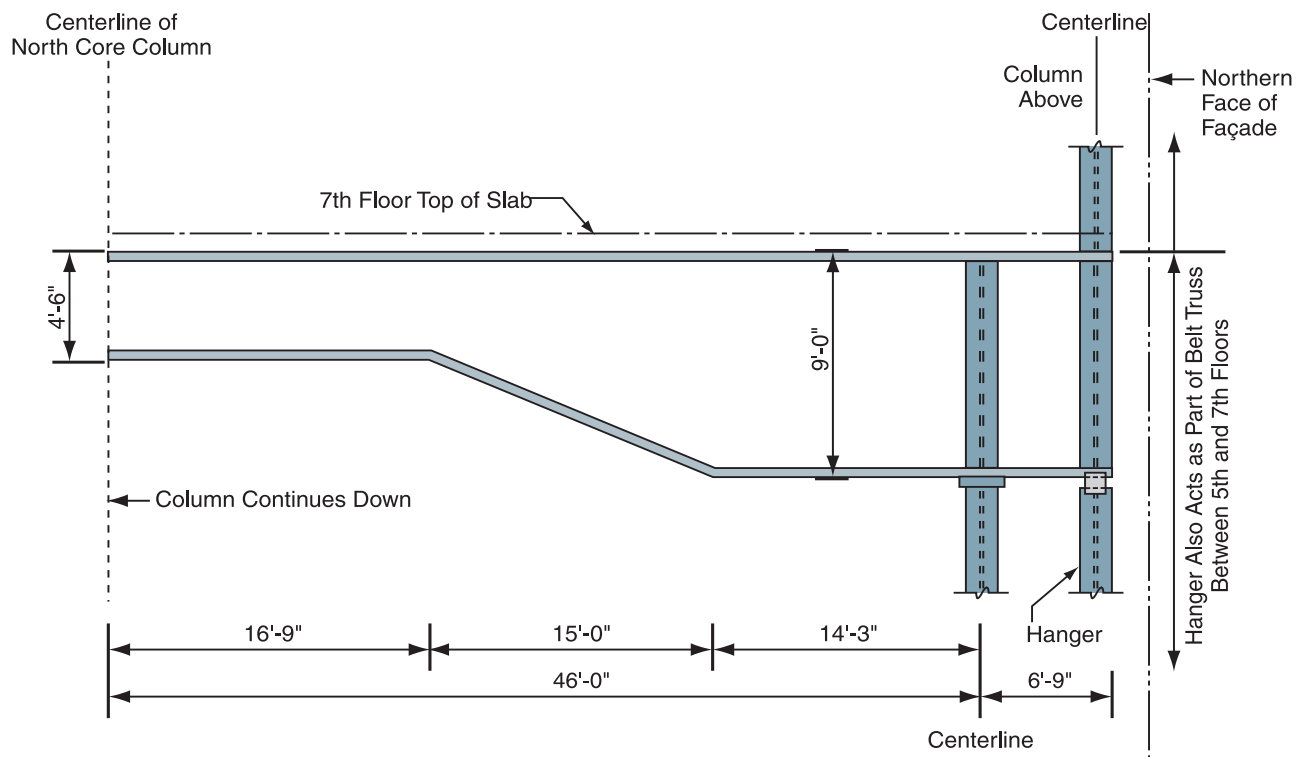
Figure 5-10 Cantilever transfer girder detail.

The cantilever transfer girders, shown in Figure 5-10, spanned between the core and the north elevation at the 7th floor. There were eight transfer girders to redirect the load of the building above the 7th floor into the columns that went through the Con Ed substation. These girders cantilevered 6 feet 9 inches between the substation and the north façade of the building above. The girders extended an additional 46 feet to the core. The two transfer girders at the east end of the building were connected to Truss 1, creating a double transfer. The girders varied in depth from 9 feet at the north end, to a tapered portion in the middle, and to 4 feet 6 inches at the southern section closest to the core. Each transfer girder weighed approximately 52 tons. At the north wall, between the 7th and 5th floors, transferred columns were also part of the belt truss that circled the building as part of the lateral-load-resisting system and acted as a transfer for the columns above the shipping ramp.

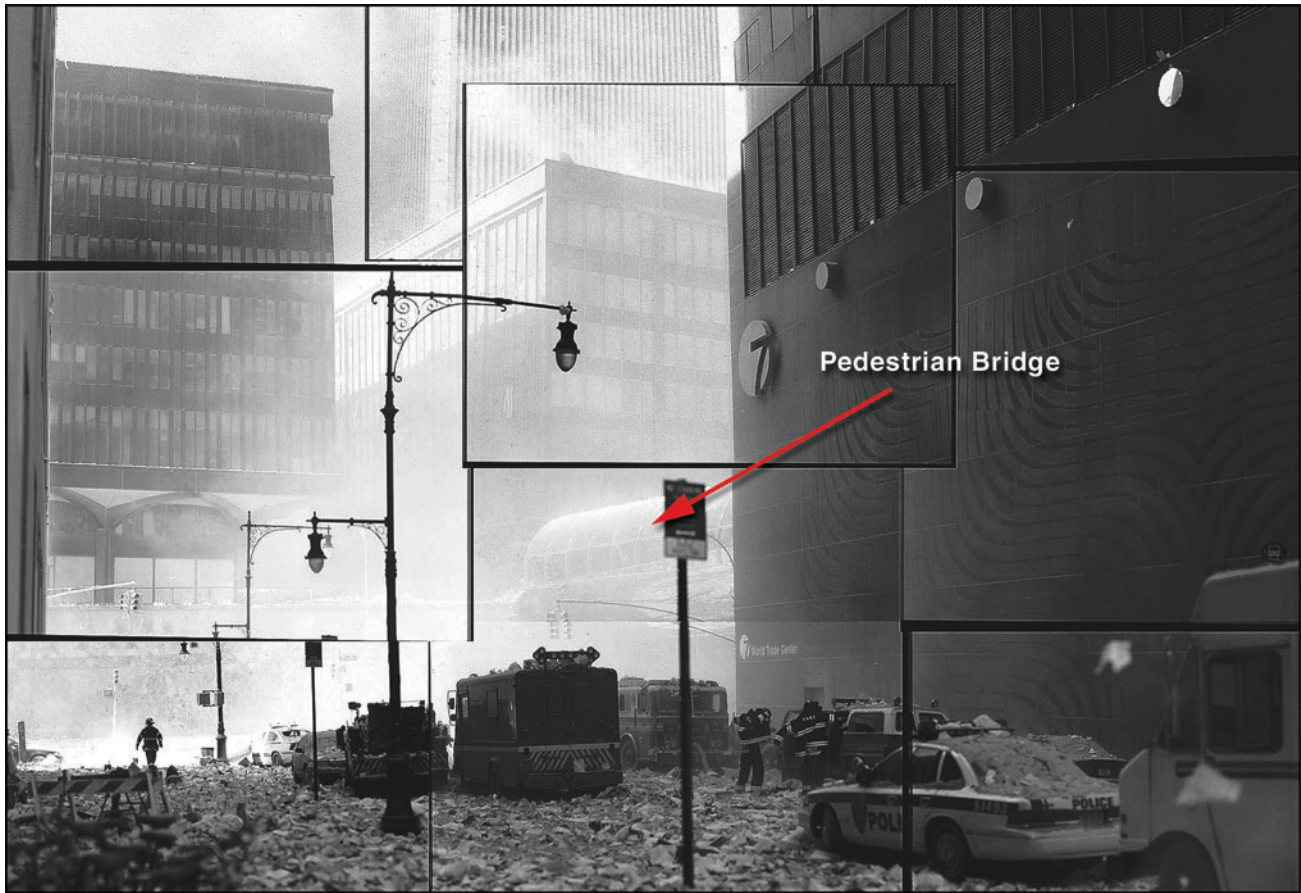
At 9:59 a.m., WTC 2 (the south tower) collapsed. The approximate extent of its debris is shown in Figure 5-12(A). It appears that the collapse of WTC 2 did not significantly affect the roof, or the east, west, and north elevations of WTC 7. It is unknown if there was any damage to the south elevation after WTC 2 collapsed, but both the covered, tubular pedestrian bridge (see Figure 5-13) and the Plaza bridge were still standing after the collapse of WTC 2.

Figure 5-13 Pedestrian bridge (bottom center) still standing after WTC 2 has collapsed, sending substantial dust and debris onto the street, but before WTC 1 (top center) has collapsed.

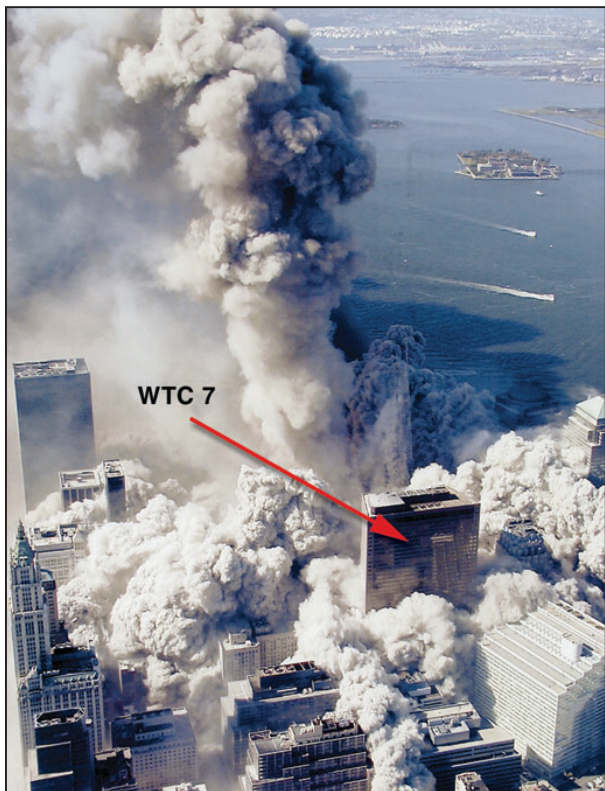
Figure 5-14 View from the north of the WTC 1 collapse and spread of debris around WTC 7. Note the two mechanical penthouses of WTC 7 are intact.

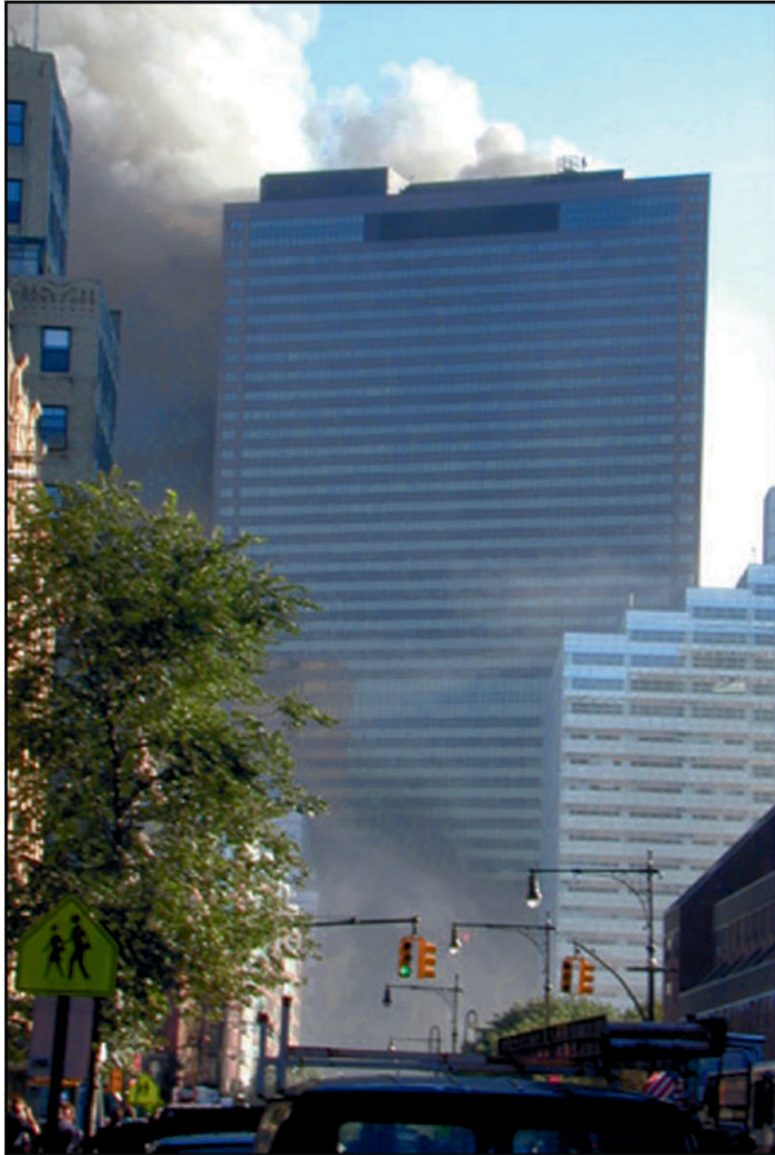
~5:20:33 p.m. WTC 7 begins to collapse. Note the two mechanical penthouses at the roof on the east and west sides in Figure 5-20.

*Figure 5-20
View from the north of WTC 7 with both
mechanical penthouses intact.*

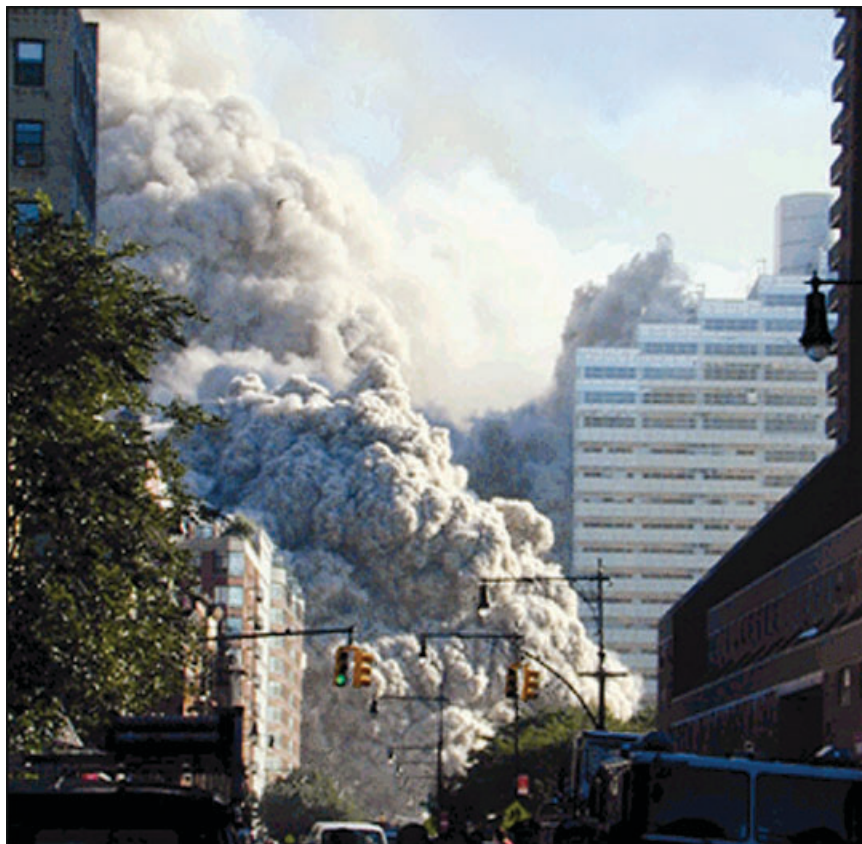
~5:21:10 p.m. WTC 7 collapses completely after burning for approximately 7 hours (Figure 5-25). The collapse appeared to initiate at the lower floors, allowing the upper portion of the structure to fall.

Figure 5-25 Debris cloud from collapse of WTC 7.
